Hurricane Ike along the upper Texas coast: An introduction

Nicholas C. Kraus, Ph.D., and Lihwa Lin, Ph.D.

U.S. Army Engineer Research and Development Center,
Coastal and Hydraulics Laboratory, 3909 Halls Ferry Rd., Vicksburg, MS 39180
Nicholas.C.Kraus@usace.army.mil

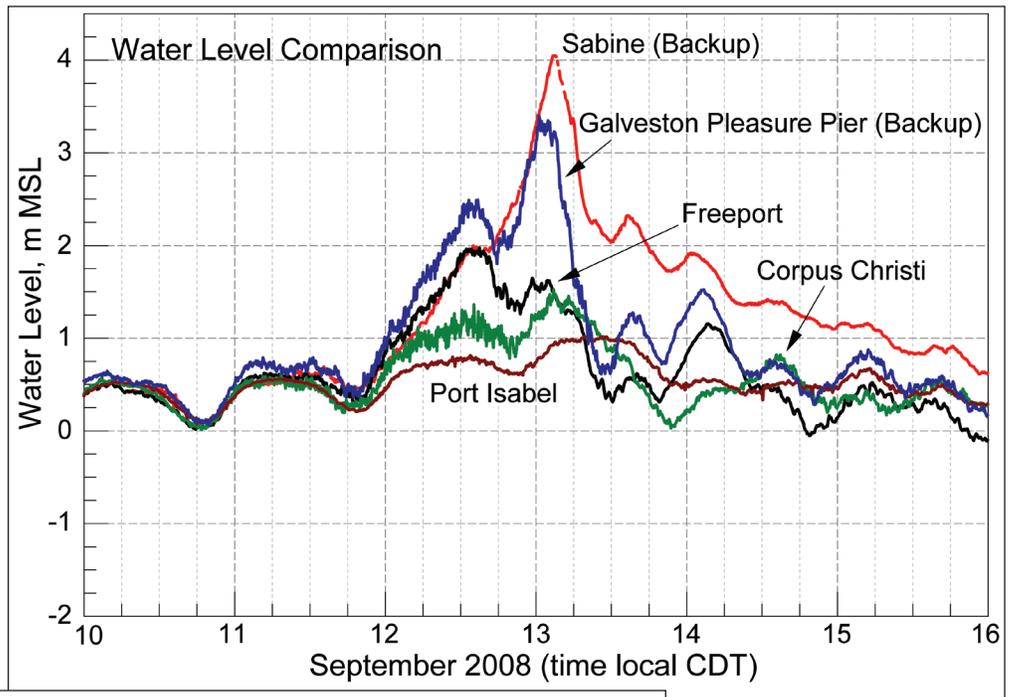
Figure 3 (right). Water level measured at several locations along the Texas coast during Hurricane Ike. The eye of the hurricane made landfall at 2 am on Saturday, 13 September, but the main surge was preceded by a large forerunner wave that arrived before midnight of Thursday, 11 September. Data plotted downloaded from <http://tidesandcurrents.noaa.gov/> and includes preliminary or unverified values.

and energy induced a large forerunner, as shown in the water levels plotted in Figure 3. These water level gauges are operated by the National Ocean Service (NOS) of the National Oceanic and Atmospheric Administration and are mounted on piers extending into the nearshore of the Gulf (Galveston Pleasure Pier, Corpus Christ Pier) or just inside large coastal inlets (Sabine, Freeport, Port Isabel). The data shown were considered preliminary by NOS at the time of writing this paper and may be subject to change. In particular, the authors plotted portions of the water level from the secondary or backup gauges at the Galveston Pleasure Pier (known as Flagship Pier locally) and Galveston Pier 21, because the primary (acoustic) gauges failed or gave questionable results. Backup gauges at these sites are based on water pressure, vented to the atmosphere to eliminate barometric pressure. A likely forerunner surge arrived around 10 p.m. local time on Thursday evening, 11 September. However, there may have been an earlier forerunner that started that morning. Figure 3 indicates that the surge was greatest at Sabine, located in right-front quadrant of the wind with respect to the eye that entered Texas at Galveston. The peak surge then decreased with distance south, although the duration remained much the same. The surge duration of a typical hurricane is less than a day, but the duration of Ike was approximately

2½ days. Such surge has profound consequences for causing beach erosion, as discussed in the next section, and for promoting wave forces on structures high on the beach (Ewing *et al.* 2009).

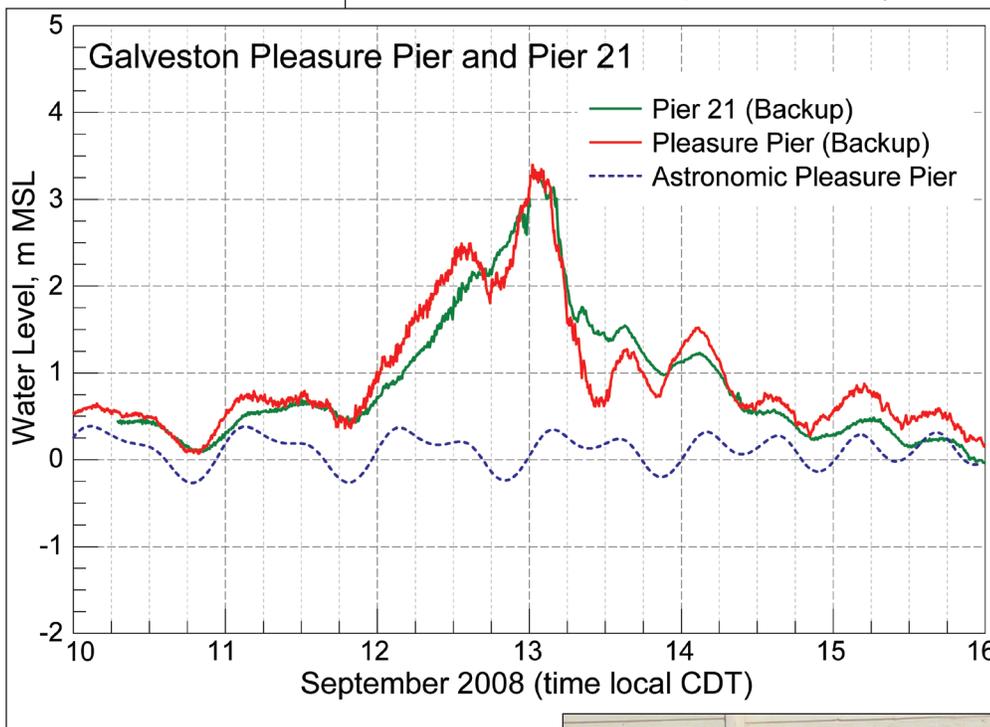
Figure 4 (left). Times series of observed water level and predicted (astronomical) tide at the Galveston Pleasure Pier (Gulf of Mexico) and Pier 21 (Galveston Bay, on other side of the barrier island from the Pleasure Pier site). The observed water level includes the surge and the tide. Data plotted downloaded from <http://tidesandcurrents.noaa.gov/> and includes preliminary or unverified values.

Water level in Galveston Bay on the north side of Galveston Island measured at the Pier 21 gauge rose synchronously with that in the Gulf of Mexico (Figure 4) measured at the Pleasure Pier gauge. The Gulf or south side of Galveston Island was raised following the 1900 hurricane during construction of the seawall (Davis 1961; USACE 1981), which provided protection from surge and waves, and improved storm drainage. However, the city area of Galveston Island slopes downward toward the bay and harbor. The bay side of Galveston was flooded by the evening of Friday, 12 September, with primary water intrusion believed to be from the bay side. Anecdotally, many residents who delayed evacuation were prevented from doing so by the forerunner, likely believing that the eye of the storm and, therefore, greatest storm intensity were still offshore. For reference, the predicted tide at the Galveston Pleasure Pier is shown in Figure 4. The tide is predominantly diurnal on this coast with diurnal range of about 0.6 m (2.0 ft).

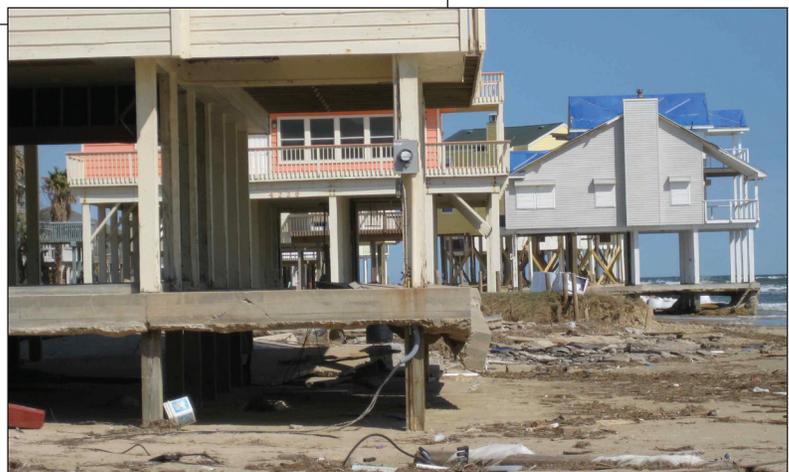
Figure 5 (right). Undermining of concrete slabs of beach residences on west Galveston Island.

On 23 October 2008, the first author inspected the beaches west of the city of Galveston. Almost all residences and buildings gulfward of the Blue Water Highway are on pilings. Blue Water Highway is a scenic coastal drive (connecting to Farm-to-Market Road 3005) that runs some 40 miles (64 km) from Seawall Boulevard in the city of Galveston to Surfside Village in Brazoria County. Structures on pilings fared well under the long duration of extreme water level, surge, and waves. However, the concrete slabs under the buildings closest to the beach were extensively undermined (Figure 5). Damage by erosion was progressively less with distance landward from the beach (Figure 6).

Buildings near the beach are inferred to have been damaged primarily by erosion induced by surge and waves, which undermined the massive concrete slabs under them. Some slabs were moved energetically by waves and the flooding current from the sea to bay, as seen in Figure 7. This photograph indicates that the slab was repeatedly moved up and down by hydrodynamic forces. Such movement stressed the pilings, tilted the structure, and caused damage that otherwise might not have occurred. Concrete slabs are constructed primarily for parking beneath the main dwelling and to serve as a foundation for large appliances and water heaters. A conclusion is that concrete slabs should not be placed under structures built on pilings that may be exposed to surge and waves. A gravel layer on top of filter cloth might be an appropriate and low-cost alternative.

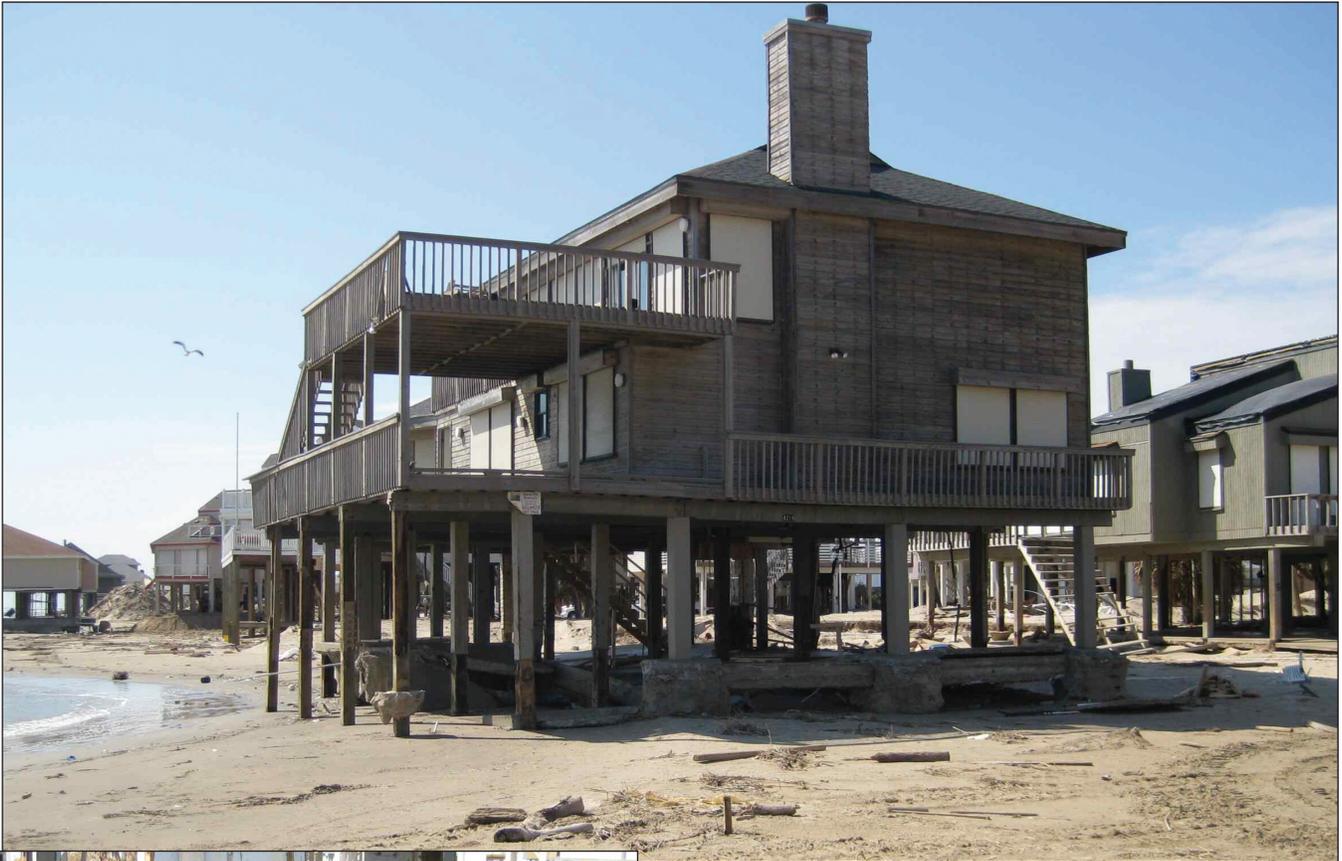
Figure 6 (above). Undermining of concrete slabs was progressively less with distance landward (to right of picture).

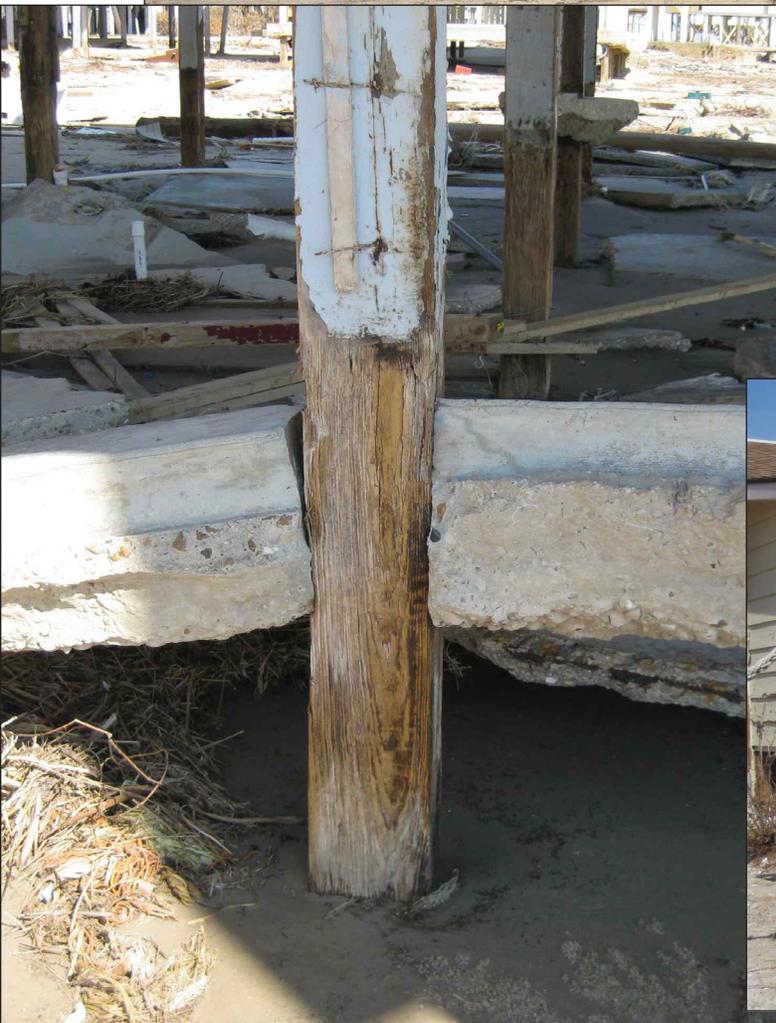
Figure 7 (left). Up and down movement of heavy concrete slab by the surge current and waves scraped this large piling, rounding and weakening it from its original square shape.

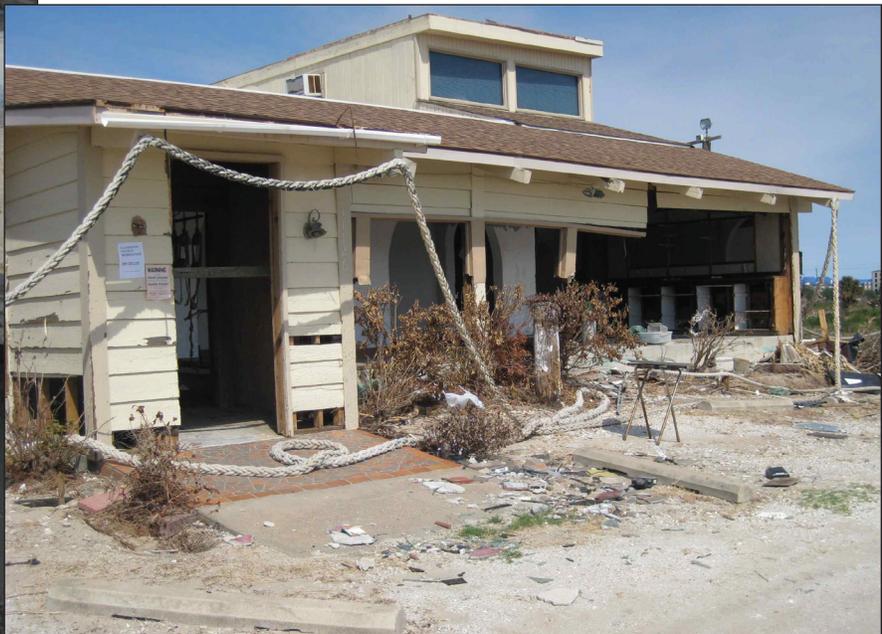
Figure 8 (below). Flood damage by surge on structure facing the Gulf of Mexico, but more than 1,500 ft (450 m) from the beach.

Older structures not on pilings were heavily damaged by the surge. The picture in Figure 8 shows such a structure, a restaurant located on the bay (north) side of FM 3005, some 1,500 ft (450 m) from the beach. Debris was driven into the building by the surge from the Gulf of Mexico and its functionality as a restaurant was destroyed.
