INLET STABILIZATION: A CASE STUDY AT MOUTH OF COLORADO RIVER, TEXAS

ROBERT C. THOMAS[1], KARL B. BROWN[2], NICHOLAS C. KRAUS[1]

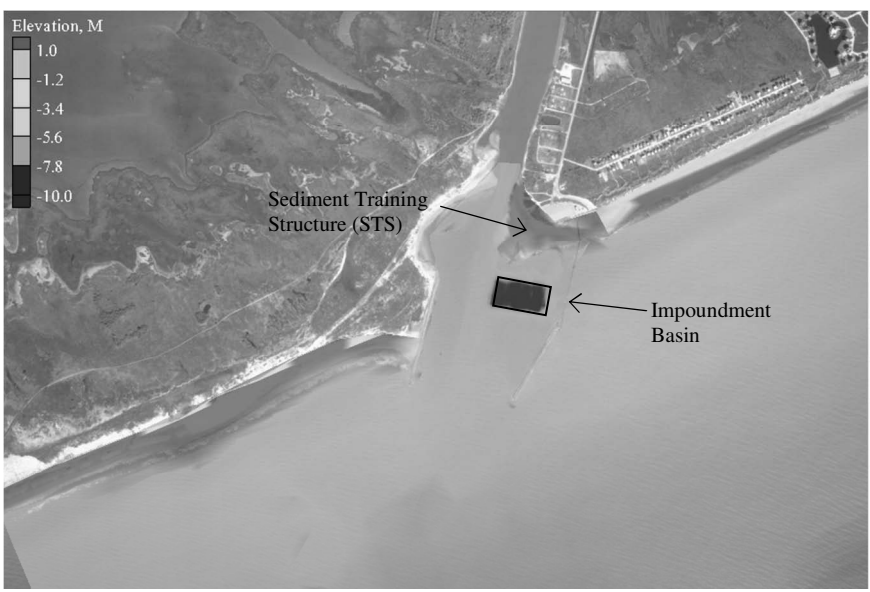
Fig. 6. Bathymetric survey Aug. 2003 (Aerial photograph date: 12/18/2003)

In response to sediment bypassing the impoundment basin, a 150-m long stone sediment training structure (STS) was constructed in 2002 to direct sediment offshore and into the impoundment basin. Figure 6 shows an August 2003 survey, after STS construction and dredging. The figure illustrates the extreme gradient between shallow water near the beach and the impoundment basin. The beach at the MCR is a popular destination for tourists and wade fishermen, but depth and proximity to shore of the impoundment basin created an unsafe environment for wading.

Changes to Federal policy regarding shallow-draft navigation channel maintenance led to cessation of dredging after construction of the STS. Without frequent dredging, it became impossible to maintain shoreline position. Within 2 years, the STS was buried by sand transported along the shore and blown over land, prompting future structures to be designed to higher elevations. Bypassing of sediment around and over the buried STS allowed spit growth to continue, advancing more than 200 m to the west between 2003 and 2006. A bathymetric survey conducted in October 2006 is shown in Figure 7, illustrating morphologic response after three years without dredging. In addition to spit growth, the impoundment basin is completely filled, and the channel has realigned to a more shore normal direction.

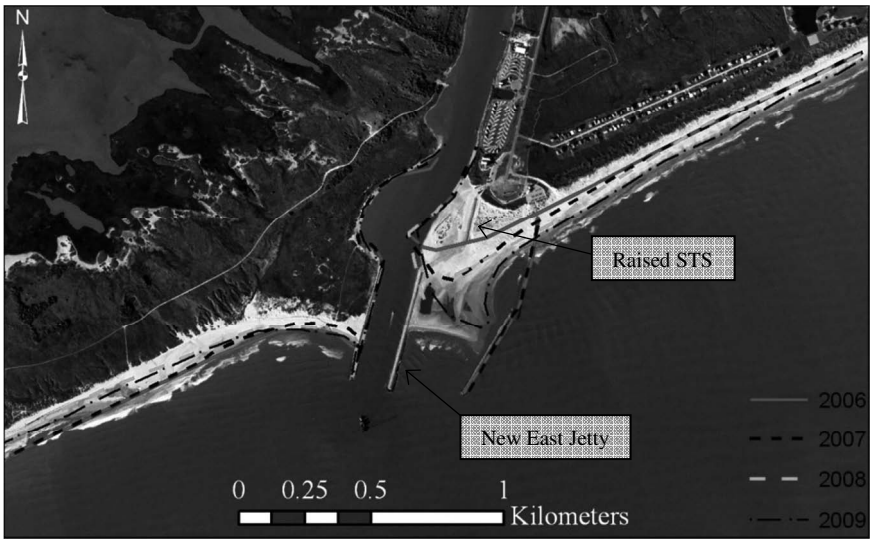
Fig. 8. MCR shoreline position 2006 – 2010 (Aerial photograph date: 11/16/2010)

To improve inlet efficiency and provide a navigable channel with less frequent dredging requirements, a new east jetty was constructed. The new jetty project was completed in November 2010, shown in Figure 8 with recent shorelines overlaid. The design process, documented in Kraus *et al* (2008), resulted in a narrow and deep channel with a new east jetty 150 m east of and parallel to the existing west jetty. The new jetty was designed to be connected to the existing STS, and crest elevation of both the STS and landward portion of the new jetty were raised to reduce wind-blown transport of sediment over the structure. The plan also included analysis of shoreline change for the new project, which

Channel condition surveys conducted in March 2009 and September 2010 were compared to assess channel morphology during construction, prior to channel dredging. Near the trunk of the west jetty, channel depth increased as much as 1.2 m to a maximum of 4.0 m Mean Low Tide (MLT – a local navigation datum); depth was greatest near the west jetty, transitioning to emergent beach within the authorized channel. At the midpoint of the jetty channel, depth had increased by 1.0 m; depth on the western side of the channel was about 1.0 m deeper than the east. Beyond the seaward end of the jetty in progress, survey data show continued channel shoaling. Field observations indicated that the deepest part of the channel was located directly adjacent to the west jetty; however; condition surveys do not extend all the way to the edge of the jetty to enable quantitative comparison.

The condition survey data indicate that increased inlet current velocity started to naturally scour a new channel along the west jetty after construction of the new jetty began. The new channel was narrow and deep immediately adjacent to the west jetty, following observations at other inlets described in Kieslich (1981). The channel did not reach its authorized depth of 4.57 m MLT and width of 45.7 m without dredging; however, the channel was deep and wide enough to

Initial observations indicate that the new jetty configuration is more efficient than the weir jetty system and will likely require less frequent dredging than the previous system. Ebb shoal formation has not yet been verified, but its presence may be assumed as judged from the patterns of sediment plumes and wave breaking in aerial photographs. A bathymetric survey is planned to investigate ebb shoal development. Periodic collection of aerial photographs will also continue to monitor inlet response to the new jetty configuration.
