Shark River Inlet, New Jersey, Entrance Shoaling: Report 1, Desk Study

Nicholas C. Kraus and Mary C. Allison

September 2009

Final report

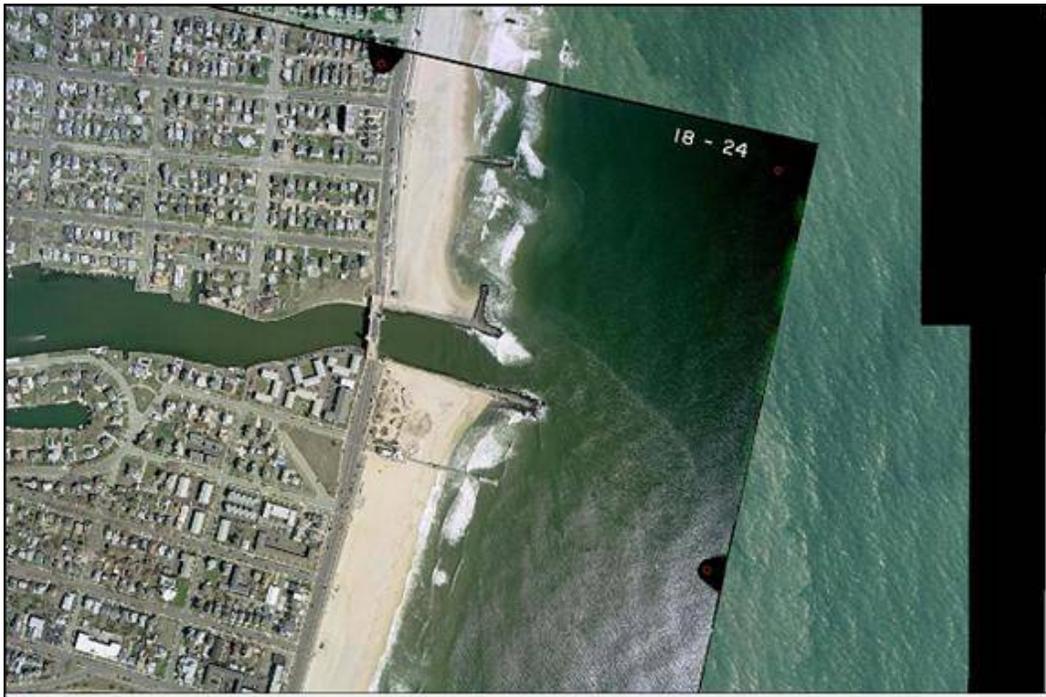
Figure 1. Shark River Inlet entrance, NJ, inset area photographed 13 April 2003.

Shark River Inlet is located in Monmouth County, NJ, and is the southernmost coastal inlet maintained by the New York District (Figures 1 and 2). There is no significant river flow to the estuary, which is fed by several small streams. The inlet is served by a federally maintained navigation channel connecting the estuary of the Shark River and the Atlantic Ocean.

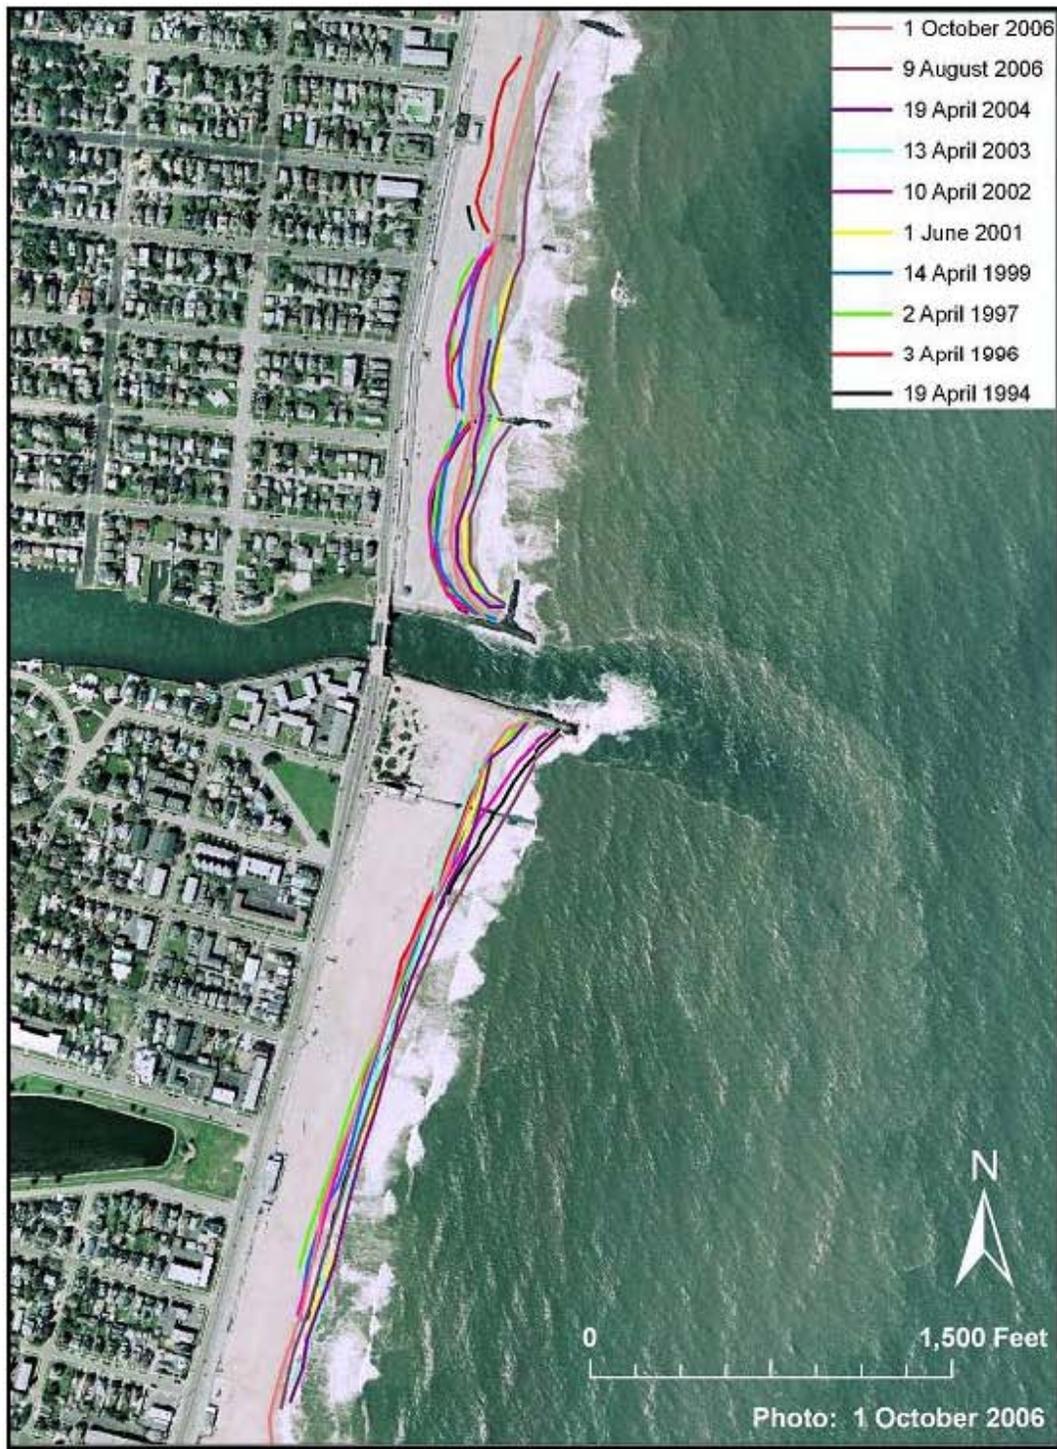
Figure 3. Shoreline change at Shark River Inlet entrance, NJ, 1994-2006.

Shoreline position in the vicinity of the inlet, from April 1994 to October 2006, was examined from aerial photography made available by the New York District, as summarized in Figure 3. The shoreline was interpreted as the visually identified wet-dry line, without tidal (water level) correction. The figure shows that the shoreline adjacent to the south jetty has been fully impounded, apart from seasonal change, similar to the situation described by Angas (1960). The shoreline adjacent to the north jetty advanced subsequent to the renourishment in 1999-2000, and the segment of shoreline behind the spur also varies in position, but maintains an advanced position protecting the landward base of the jetty. The seaward positions of the shoreline on both sides of the inlet suggest that sand can readily enter its entrance or move onto the newly formed ebb shoal. The large impoundment area adjacent to the south jetty indicates a consistent net longshore sand transport to the north.
